REMEDIAL ACTION PROGRAM
for
TANK REMOVAL AND THE CONTAINERIZATION of
CONTAMINATED SLUDGES AND SOILS at
SUPERIOR SOLVENTS COMPANY
ST. LOUIS, MISSOURI

March 3, 1988
REACT Project 1773.2

Prepared by
Jonathan R. Spencer
Director of Engineering
RYCKMAN'S EMERGENCY ACTION AND CONSULTING TEAM
2208 Welsch Industrial Court
St. Louis, Missouri 63146

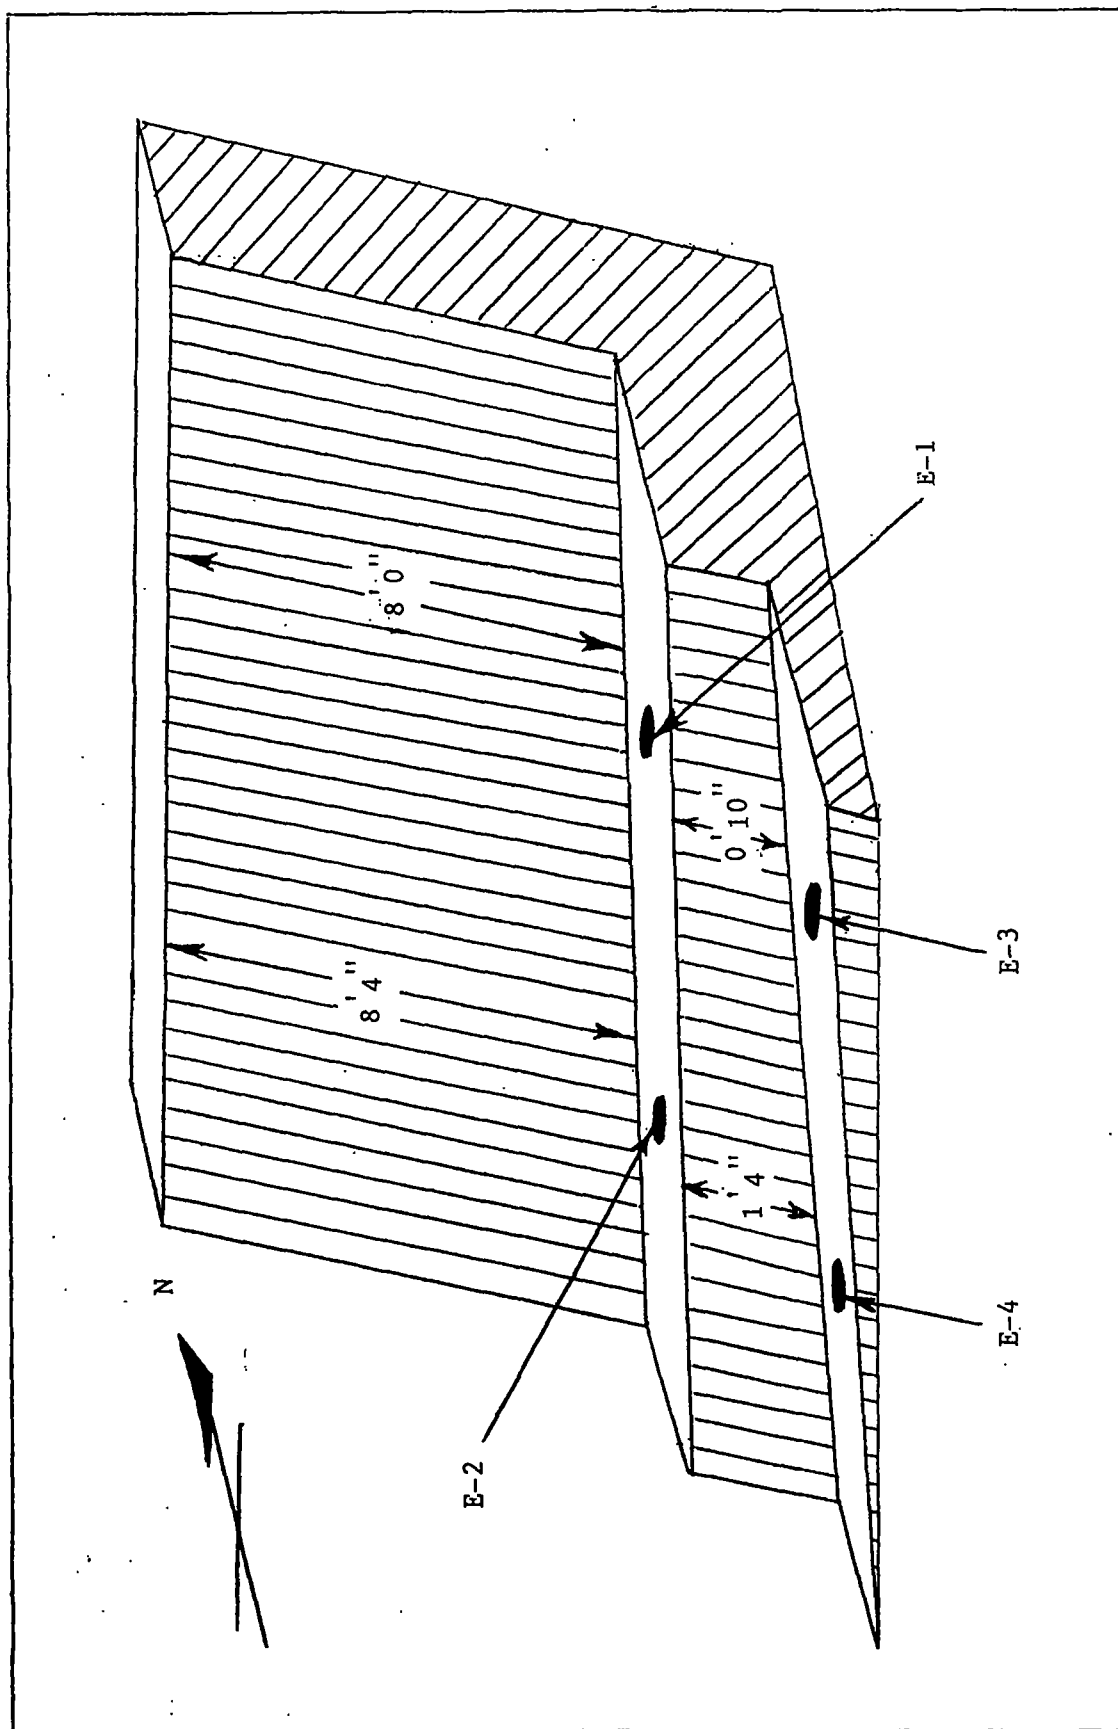
Figure 29. Schematic showing the relative location of the four soil sampling points in the excavation.

Once all of the visibly contaminated soils had been removed from the excavation, four discrete soil samples were collected from the bottom surface (Figure 18). Two of these samples (#E-1 and #E-2) were taken from depths of 8'0" and 8'4" north of the excavation centerline. The remaining two samples (E-3 and E-4) were "deep" samples taken south of the excavation centerline at depths of 8'10" and 9'8", respectively. The relative location of these four sampling points are shown in Figure 29. In each case, samples were collected by personnel in level "C" protective gear using a stainless steel trowel which had been decontaminated with a soap and water wash, deionized water rinse, acetone rinse, and a final rinse with deionized water. Soil samples were placed in laboratory cleaned glass jars (I-Chem Lot #10208713) and packed in individual paint cans for shipment to the laboratory. The sample transmittal form and chain-of-custody record is attached as Appendix IV. All four samples were analyzed for 2, 3, 7, 8-TCDD, B/N/A's, and total phenols. In addition, samples #E-2 and #E-4 were also run for volatile organics. A copy of the laboratory results is presented in Appendix I.
